SERIOUS INCIDENT

Aircraft Type and Registration:	Airbus A320-216, EC-KLT	
No & Type of Engines:	2 CFM56-5B6 turbofan engines	
Year of Manufacture:	2007 (Serial no: 3376)	
Date & Time (UTC):	26 August 2019 at 1205 hrs	
Location:	On approach to Birmingham Airport	
Type of Flight:	Commercial Air Transport (Passenger)	
Persons on Board:	Crew - 6	Passengers - 189
Injuries:	Crew - None	Passengers - None
Nature of Damage:	None	
Commander's Licence:	Airline Transport Pilot's Licence	
Commander's Age:	40 years	
Commander's Flying Experience:	9,700 hours (of which 8,080 were on type) Last 90 days - 150 hours Last 28 days - 61 hours	
Information Source:	AAIB Field Investigation

Synopsis

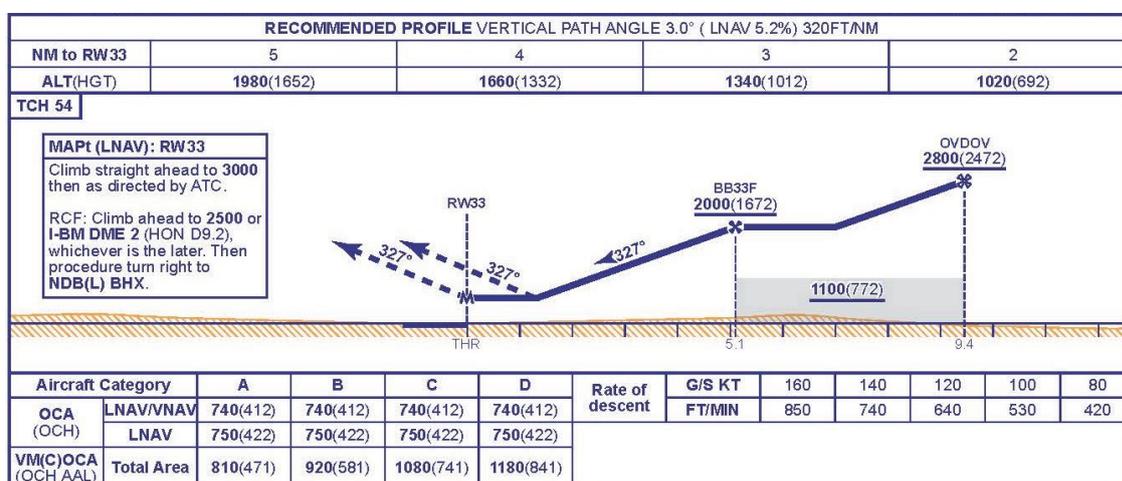
Figure 1

The aircraft was at 4,000 ft approximately 11 nm south of the airport when ATC cleared it to descend to 2,000 ft and carry out the RNAV approach (Figure 1). The pilots read back the clearance correctly but, thirty seconds later, the aircraft had not changed altitude and they contacted ATC to request descent. ATC again cleared the aircraft to descend to 2,000 ft and to carry out the approach. The aircraft was 10.5 nm from the runway when it started descending. At 9.4 nm it was at 3,800 ft, 1,000 ft above the correct profile.

Vertical profile of RNAV approach to Runway 33 at Birmingham Airport
(Extract from UK Aeronautical Information Publication)

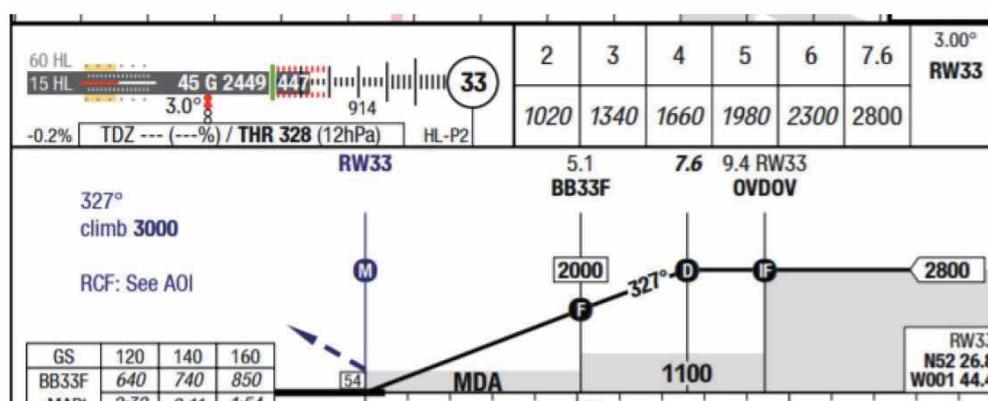
Figure 2

The investigation also highlighted a difference between the descent profile for the RNAV approach published in the UK AIP⁵ and that published by the operator's chart provider⁶. Whilst the former had a platform altitude for the approach of 2,000 ft with final descent starting at 5.1 nm from the threshold, the operator's approach charts showed a continuous descent starting from 2,800 ft at 7.6 nm (Figure 2). This led to confusion by the pilots when initially they were cleared to 2,000 ft on the first approach, causing them to delay their descent and to ask ATC again for the descent instructions. This had served to compound the issue of the late configuration of the aircraft for the approach whilst trying to slow down, resulting in the aircraft not establishing on the correct approach profile and leading to the missed approach.

Extract from operator's chart for RNAV approach to Runway 33 at Birmingham

The aircraft did not maintain the correct vertical profile because the pilots were not sure when to commence the final descent. The depiction of the descent profile on charts provided by the operator may have contributed to this uncertainty.

Different chart providers have different ways of depicting approach profiles. However, the AIP remains the source document and ATC will naturally rely on this, rather than individual operator's charts, when managing air traffic. Where differences exist, it is desirable for operators and ATC to ensure their effect is understood.

The operator and air traffic services provider are working to gain a better understanding of each other's approach requirements.
