**SERIOUS INCIDENT**

<b>Aircraft Type and Registration:</b>	Airbus A320-214, OE-LOA
<b>No &amp; Type of Engines:</b>	2 CFM56-5B turbofan engines
<b>Year of Manufacture:</b>	2007
<b>Date &amp; Time (UTC):</b>	1 March 2019 at 2020 hrs
<b>Location:</b>	London Stansted Airport
<b>Type of Flight:</b>	Commercial Air Transport (Passenger)
<b>Persons on Board:</b>	Crew - 7                      Passengers - 169
<b>Injuries:</b>	Crew - None                      Passengers - 10 (Minor)
<b>Nature of Damage:</b>	Left engine contained failure
<b>Commander's Licence:</b>	Air Transport Pilot's Licence
<b>Commander's Age:</b>	44 years
<b>Commander's Flying Experience:</b>	14,128 hours (of which 10,308 were on type) Last 90 days - 195 hours Last 28 days - 71 hours
<b>Information Source:</b>	AAIB Field Investigation

**Synopsis**

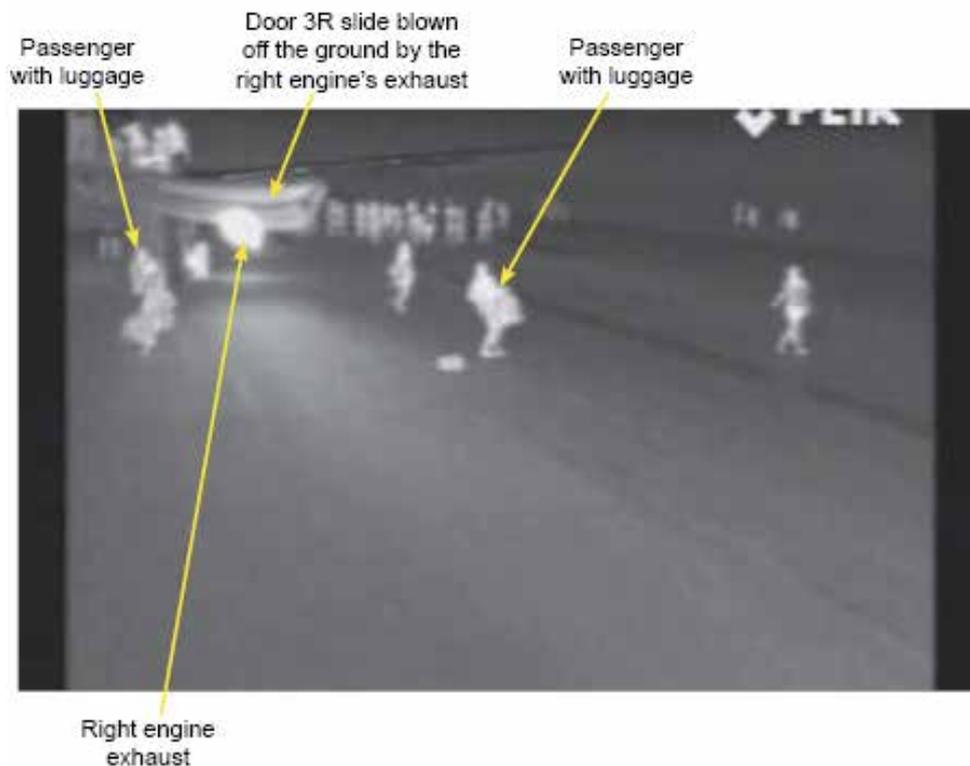
**Figure 2**

Numerous passengers also commented that the aisle and Doors 2L and 2R and the overwing exits, were impeded as people were trying to take their baggage from under seats and overhead bins. As a result, passengers were shouted at by some to leave their baggage behind. One passenger thought that about half of the passengers took their hand baggage with them. Images of passengers leaving the aircraft with baggage from the right overwing exit were captured by the RFFS’s onboard infrared CCTV camera (Figure 2).

RFFS infrared CCTV showing some passengers leaving with baggage

It is recommended that the European Union Aviation Safety Agency commission research to determine how to prevent passengers from obstructing aircraft evacuations by retrieving carry-on baggage.

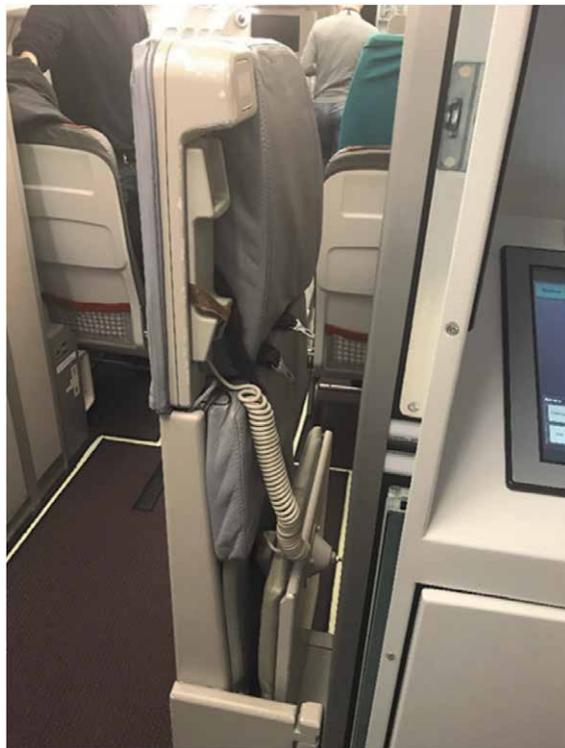
**Figure 5**

The SFA then tried to call FA3, in the rear of the aircraft, using the interphone, to check if everything was alright. However, when FA3 stood up, his crew swivel seat displaced the attached handset from its stowage and its cable became trapped in the now folded seat<sup>5</sup>. This caused the crew high/low chime<sup>6</sup> in the cabin to be suppressed so it was difficult for the SFA to attract FA3's attention. There then followed an exchange between the SFA and FA3 which resulted in the SFA commanding an evacuation over the PA. See the *Flight attendants' comments* section for details of this exchange. Upon hearing the command, the FAs and passengers commenced the evacuation.

Example picture of interphone dislodged from the cradle and trapped in the stowed seat

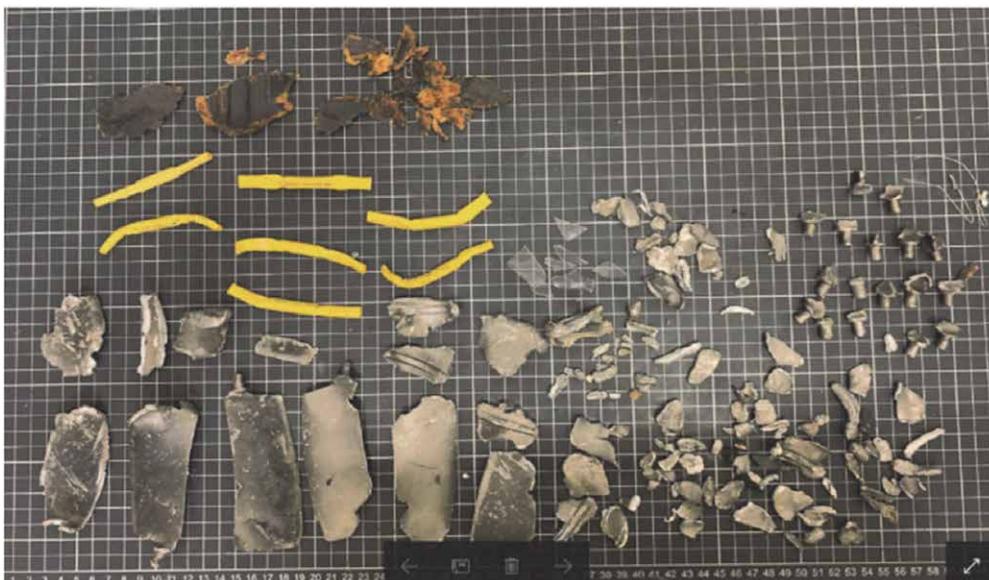
**Figure 10**

The aircraft had been moved from the runway but debris which had exited the left engine was collected from the runway by the Airport Authority and provided to the AAIB (Figure 10). The items collected included multiple IGVs, fragments of compressor blades and fragments of engine acoustic liner.

Items collected from the runway

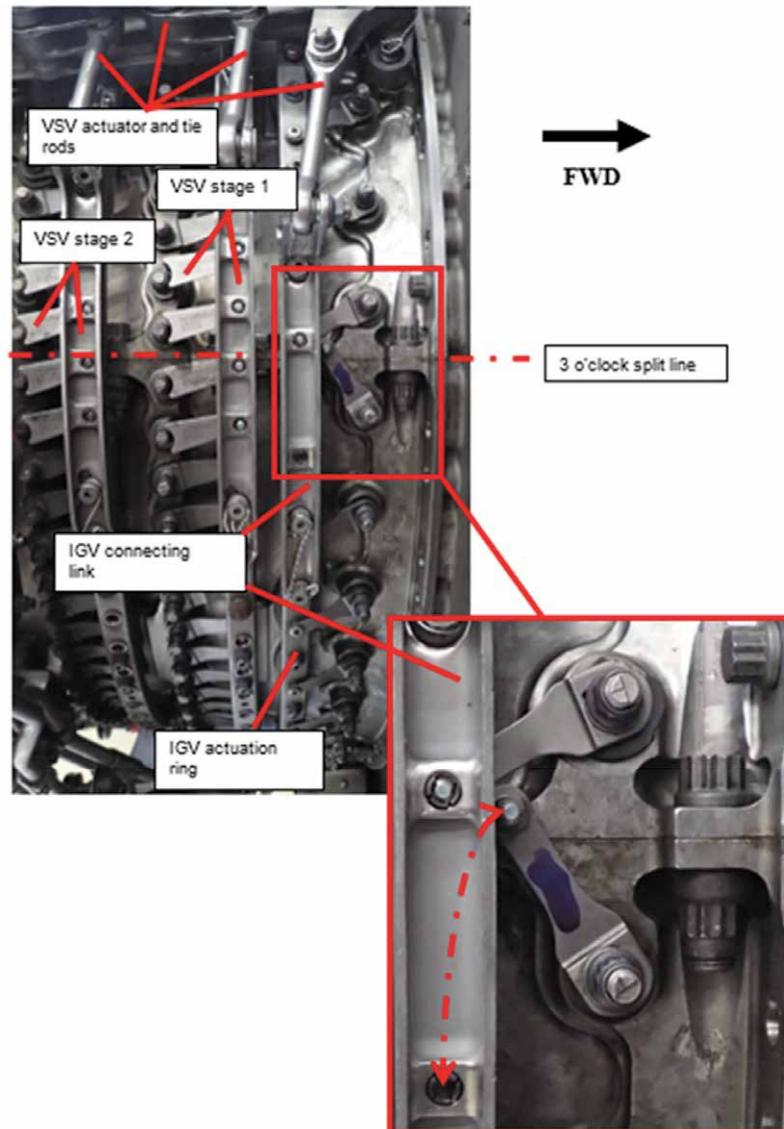
**Figure 11**

A single IGV lever arm in the 3 o'clock position (aft looking forward) immediately below the split-line of the HPC case, was found to be disengaged from the connecting link on the IGV actuation ring (Figure 11). This lever exhibited no distortion or damage but did have a small impact mark on its forward edge, which coincided with where the lever arm could come in to contact with the HPC case if it was not connected to the connecting link. There was no corresponding mark on the HPC case. Approximately half of the remaining IGV lever arms were bent or distorted and many of the bushings in the IGV actuation ring were absent or damaged.

Lever arm disconnected from connecting link on IGV actuation ring

The release of the HPC stage 1 blades resulted in separation of all the IGVs and the forces experienced by the vanes would have been transmitted through the lever arms and into the actuation ring. The absence of damage on the disconnected lever arm indicates that it was disconnected from the connecting link prior to, and not as a result of, the engine failure.

The IGV actuation ring connecting links were removed and reassembled during the recent engine repair, and it is probable that mis-assembly of the lever arm occurred at this time. The relevant ESM task contains instructions for a visual inspection to verify proper installation of the lever arms. But the mis-assembly was not identified by maintenance staff during installation of the IGV connecting link, visual inspection, or during other maintenance conducted in the immediate vicinity of the lever arm.

The engine manufacturer has considered these aspects and determined that the addition of further instructions in the ESM is not likely to be an effective mitigation. Mitigating or eliminating the possibility of an improperly assembled IGV/VSV lever would require an engine redesign which it does not consider feasible based on the low rate of occurrence. It further indicated that the limited space, concentration of moving parts and engine temperatures in the vicinity of the IGV/VSV actuation rings would preclude the installation of a placard to highlight the correct assembly of the IGV/VSV connecting links.

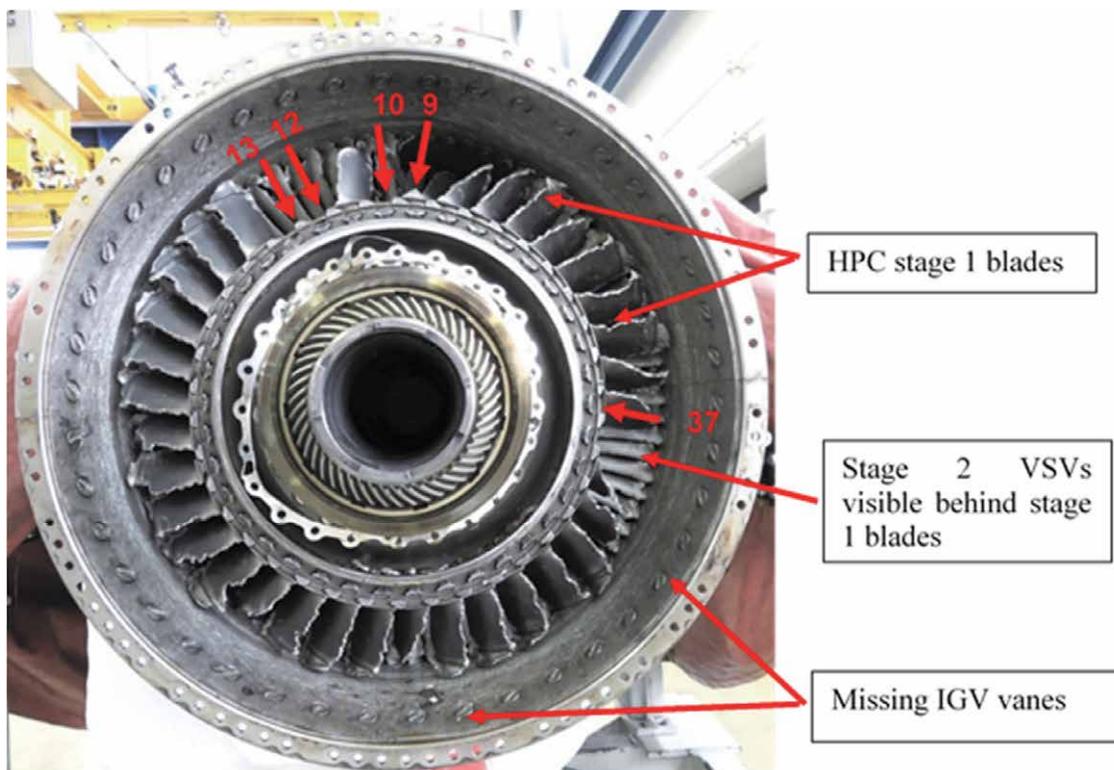
**Figure 12**

Disassembly of the HPC module showed that all the IGVs had sheared at their outer platform. All 38 HPC stage 1 blades were damaged. Four blades (Nos 10, 12, 13 and 37) had ruptured below the blade platform and one blade (No 9) had separated above the blade platform, releasing the remainder of the blade (Figure 12). Another three blades exhibited cracking below the platform.

The damage to HPC stator vanes and blades downstream of stage 1 was consistent with secondary impact damage from the release of the stage 1 blades and the resulting rotor imbalance.

HPC module showing missing IGVs and damaged stage 1 blades

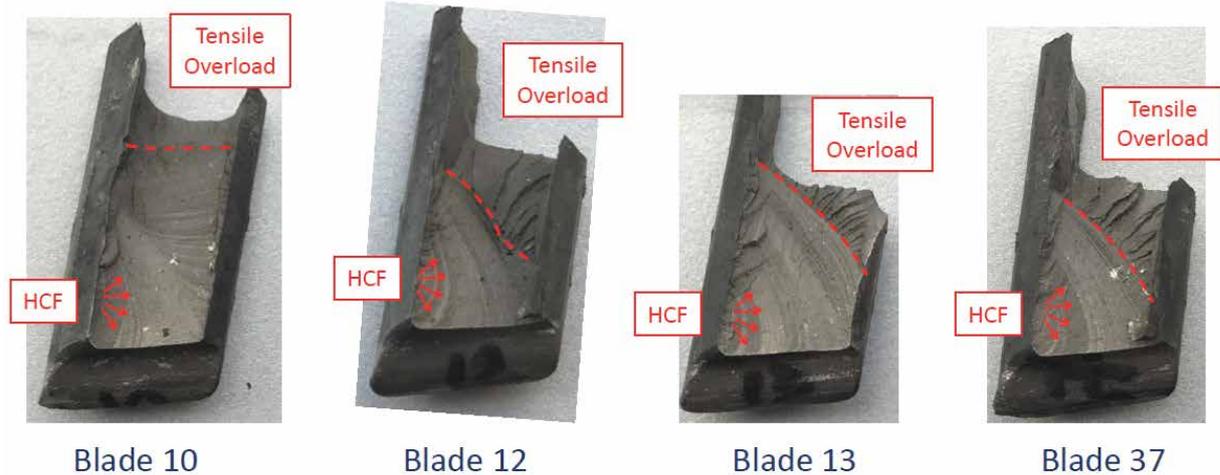
**Figure 13**

Detailed examination of the fracture surfaces of the HPC stage 1 blades which had separated below the platform, showed initiation of high-cycle fatigue (HCF) above the pressure surface on the concave side of the blade, near the leading edge. The fatigue had propagated downward and through the thickness of the blade. Beyond the area of HCF, the fracture surface was consistent with tensile overload. Blade 10, which exhibited the greatest area of fatigue, was most likely the first blade to be released (Figure 13). The fracture surface of the blade which had failed above the platform was consistent with tensile overload and had been heavily smeared, which was indicative of secondary damage.

On the blades which exhibited below-platform cracking, the cracking was consistent with the initiation of HCF in the blade dovetail, but the fatigue had not yet propagated to the point of tensile overload.

Fracture surfaces of blades exhibiting below-platform liberation

The left engine experienced a contained failure as a result of the release of several HPC stage 1 blades. The blade failures were caused by crack progression due to HCF with final failure due to tensile overload. Several other blades also exhibited fatigue initiation in the blade dovetail. The fatigue failures on the liberated blade fracture surfaces were consistent with failure due to a known aerodynamic excitation phenomenon which results from an off-schedule IGV/VSV condition and creates stresses in the blade which are beyond the design limit. One IGV lever arm was found disconnected from the connecting link on the IGV actuating ring and would have provided the stimulus for the aerodynamic excitation.
