# NATIONAL TRANSPORTATION SAFETY BOARD

## AIRCRAFT ACCIDENT REPORT

In-flight Breakup Over the Atlantic Ocean  
Trans World Airlines Flight 800  
Boeing 747-131, N93119  
Near East Moriches, New York  
July 17, 1996

**NTSB/AAR-00/03  
DCA96MA070  
PB2000-910403  
Notation 6788G  
Adopted August 23, 2000**

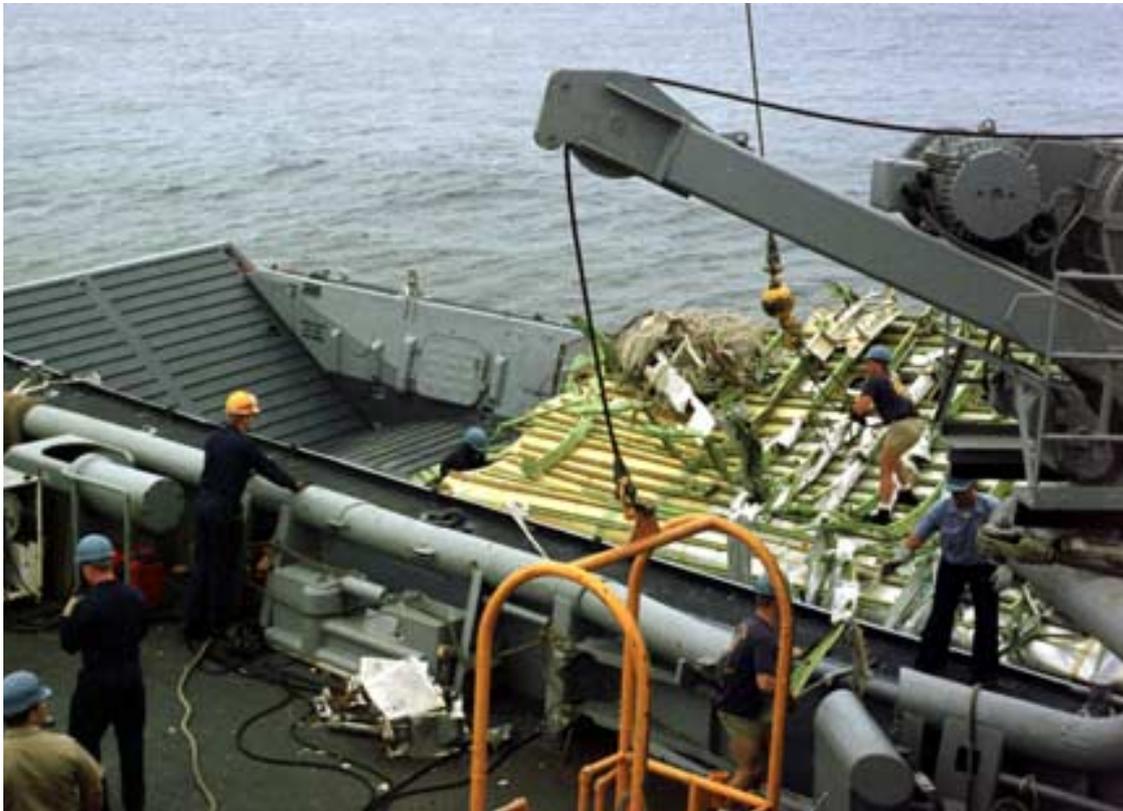
**Figure 24.** A photograph showing wreckage recovered with tangled and damaged wires attached.
