**SERIOUS INCIDENT**

<b>Aircraft Type and Registration:</b>	Airbus A320-214, OE-LOA
<b>No &amp; Type of Engines:</b>	2 CFM56-5B turbofan engines
<b>Year of Manufacture:</b>	2007
<b>Date &amp; Time (UTC):</b>	1 March 2019 at 2020 hrs
<b>Location:</b>	London Stansted Airport
<b>Type of Flight:</b>	Commercial Air Transport (Passenger)
<b>Persons on Board:</b>	Crew - 7                      Passengers - 169
<b>Injuries:</b>	Crew - None                      Passengers - 10 (Minor)
<b>Nature of Damage:</b>	Left engine contained failure
<b>Commander's Licence:</b>	Air Transport Pilot's Licence
<b>Commander's Age:</b>	44 years
<b>Commander's Flying Experience:</b>	14,128 hours (of which 10,308 were on type) Last 90 days - 195 hours Last 28 days - 71 hours
<b>Information Source:</b>	AAIB Field Investigation

**Synopsis**

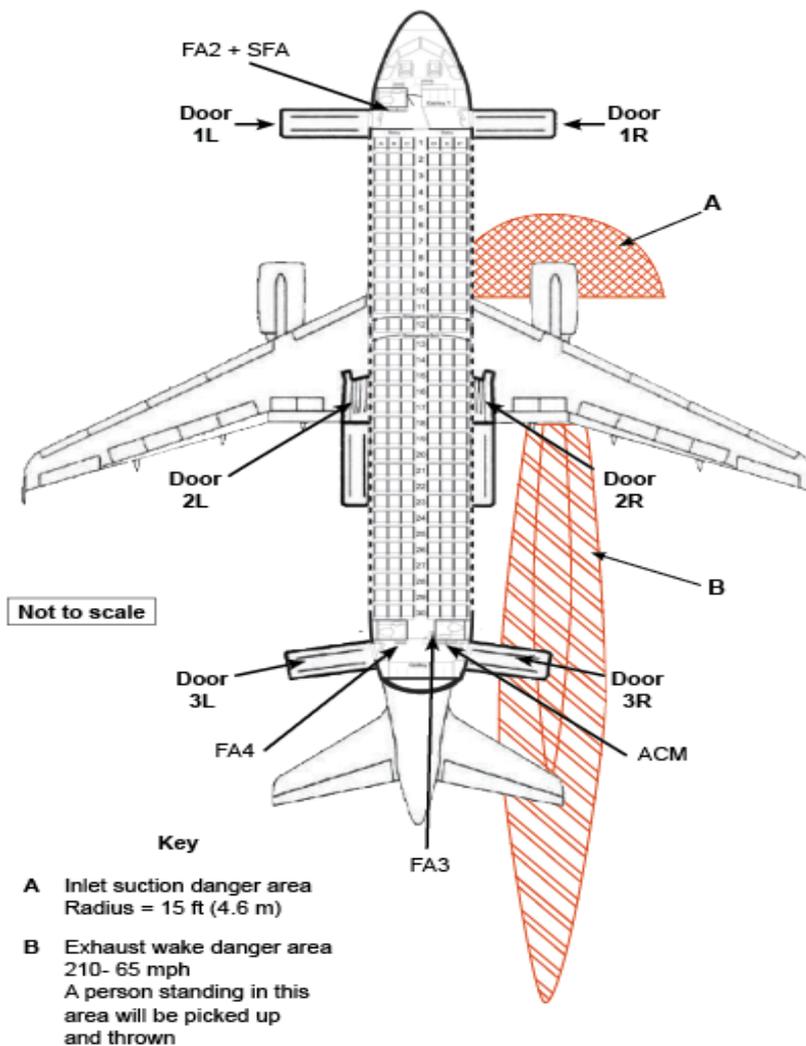
**Figure 1**

A320 doors, FA seating locations and engine hazard areas

Of those passengers that used Door 2R, several commented that they were either nearly blown over, or were blown over several times by the jet exhaust from the right engine, with some of their belongings blown away. Figure 1 shows passengers crossing behind the engine exhaust could have been exposed to 'wind' speeds of 65 mph or greater, even with the engines running at idle.

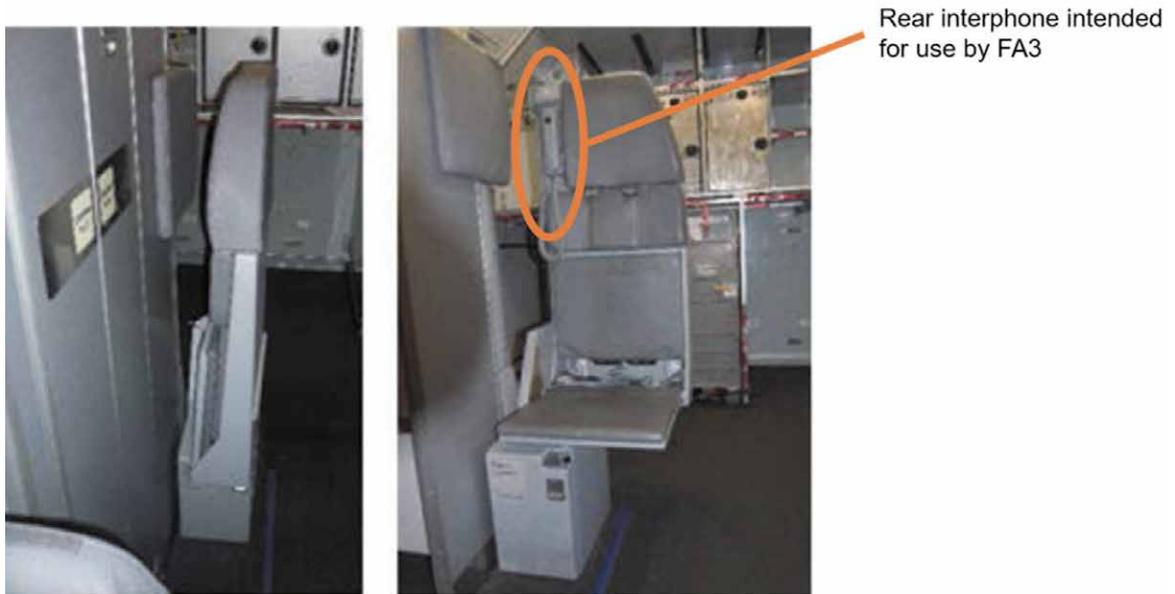
**Figure 4**

The SFA then tried to call FA3, in the rear of the aircraft, using the interphone, to check if everything was alright. However, when FA3 stood up, his crew swivel seat displaced the attached handset from its stowage and its cable became trapped in the now folded seat<sup>5</sup>. This caused the crew high/low chime<sup>6</sup> in the cabin to be suppressed so it was difficult for the SFA to attract FA3's attention. There then followed an exchange between the SFA and FA3 which resulted in the SFA commanding an evacuation over the PA. See the *Flight attendants' comments* section for details of this exchange. Upon hearing the command, the FAs and passengers commenced the evacuation.

A rear aisle swivel seat folded away from the wall and locked into position to provide a forward-facing view into the passenger cabin. When the release latch was lifted, the seat automatically folded back into the stowed position (Figure 4).

The rear interphone intended for use by FA3 was located on the aisle swivel seat.

Rear aisle swivel seat in stowed (left) and forward-facing (right) positions

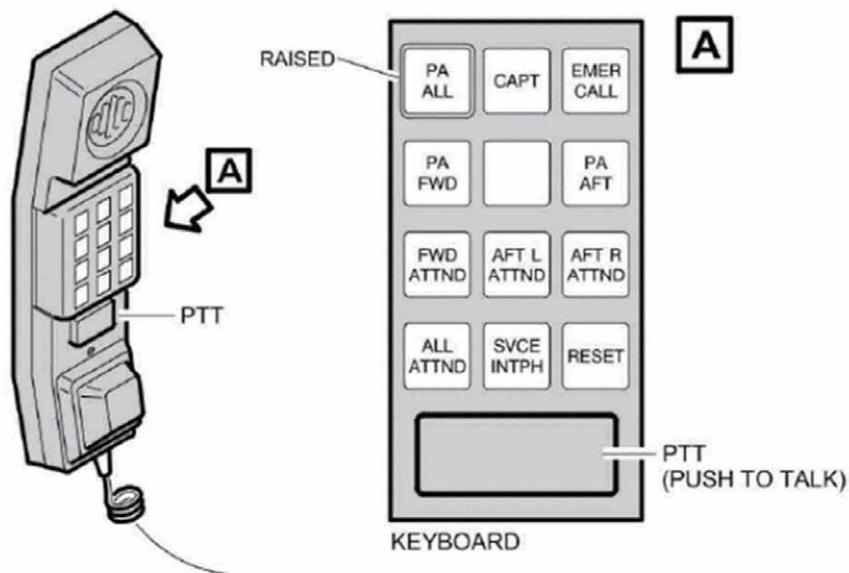
**Figure 6**  
Interphone handset

Figure 6 shows the buttons available on the passenger cabin interphones. It was possible to call the FA3 interphone handset individually from the front handset using the AFT R[IGHT] ATTND [FLIGHT ATTENDANT] button or to call all handsets together using the ALL ATTND button. If the handset was called individually, and it was not fitted on its cradle, the attention getters of the chime and panel lights would not activate.
