# NATIONAL TRANSPORTATION SAFETY BOARD

## AIRCRAFT ACCIDENT REPORT

In-flight Breakup Over the Atlantic Ocean  
Trans World Airlines Flight 800  
Boeing 747-131, N93119  
Near East Moriches, New York  
July 17, 1996

**NTSB/AAR-00/03  
DCA96MA070  
PB2000-910403  
Notation 6788G  
Adopted August 23, 2000**

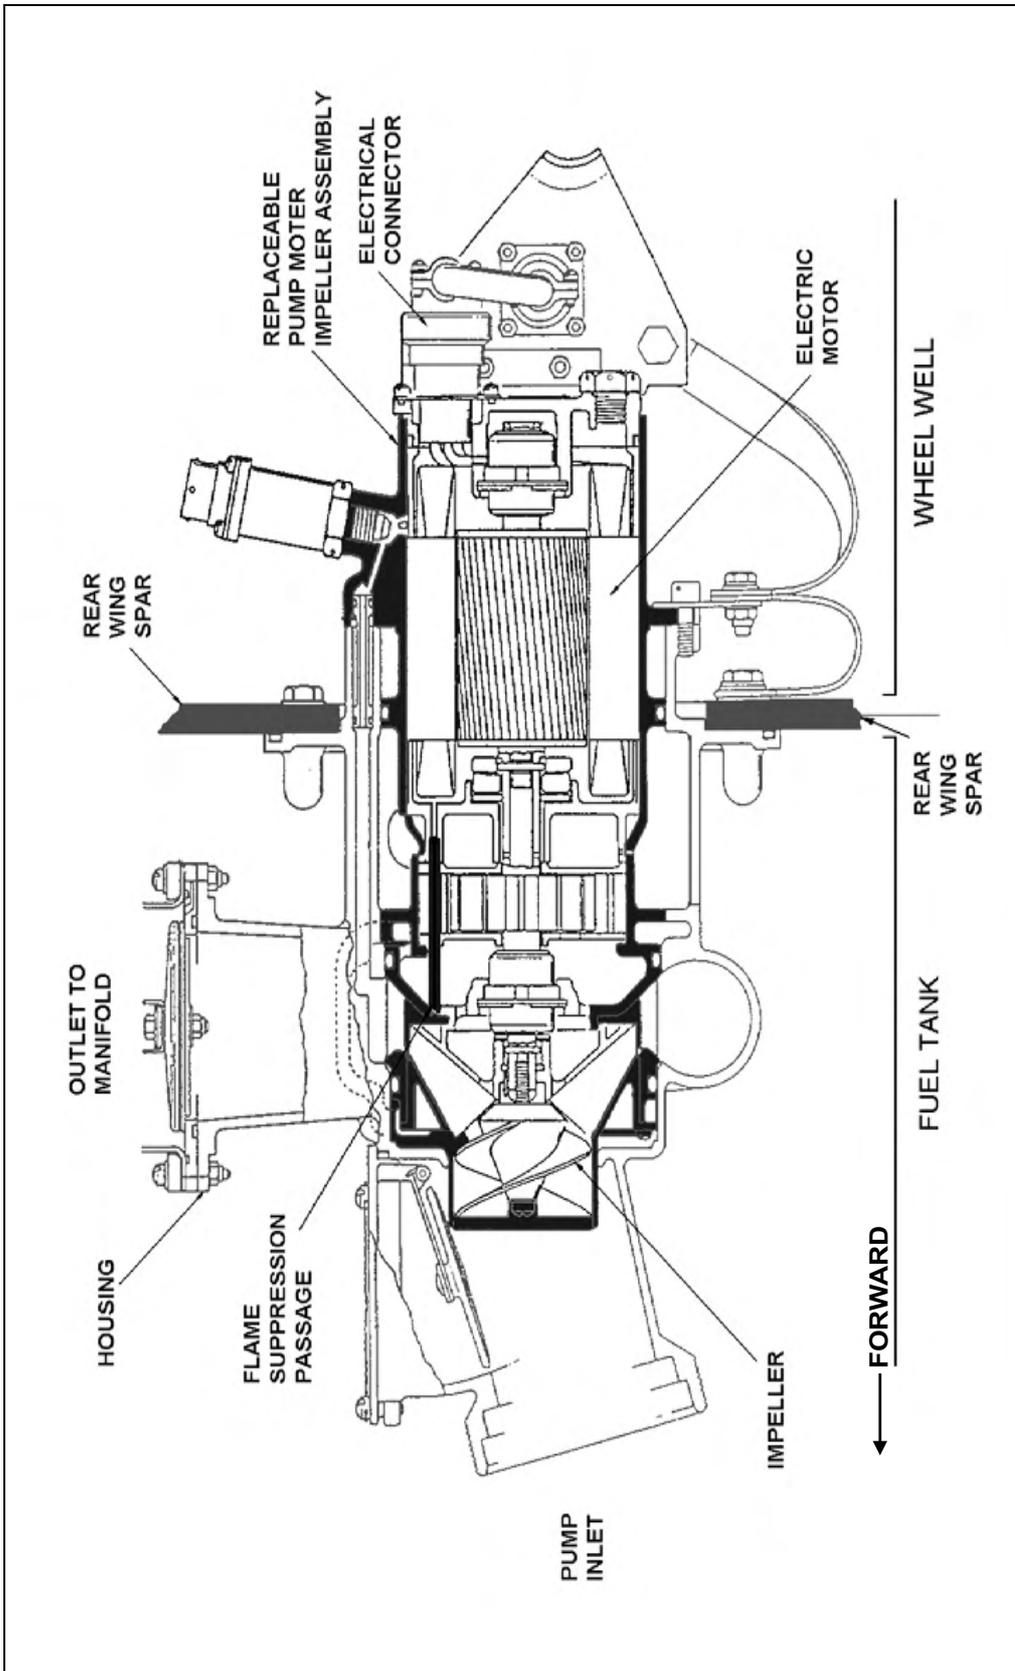
Figure 23. A diagram of a jettison/override fuel pump.

Both jettison/override pumps from the CWT were recovered, examined, and tested. The jettison/override pumps were impact damaged (especially at the aft ends, where they had been attached to the rear spar), but exhibited no evidence of electrical shorts, arcing, preimpact breaching of the housing, or discoloration of the pump shaft. (Figure 23 is a diagram of a jettison/override fuel pump.) Examination revealed that the jettison/override pumps' thermal fuses and flame arrestor tubes were intact and exhibited no evidence of thermal or flame exposure. The CWT jettison/override pump motors exhibited no evidence of heat-related discoloration; the motor windings were the same tan color as those from the wing fuel tanks. (A similar jettison/override pump was heated in a laboratory test until the thermal fuse melted at slightly less than 400° F, and the motor windings were subsequently found to have darkened substantially.)

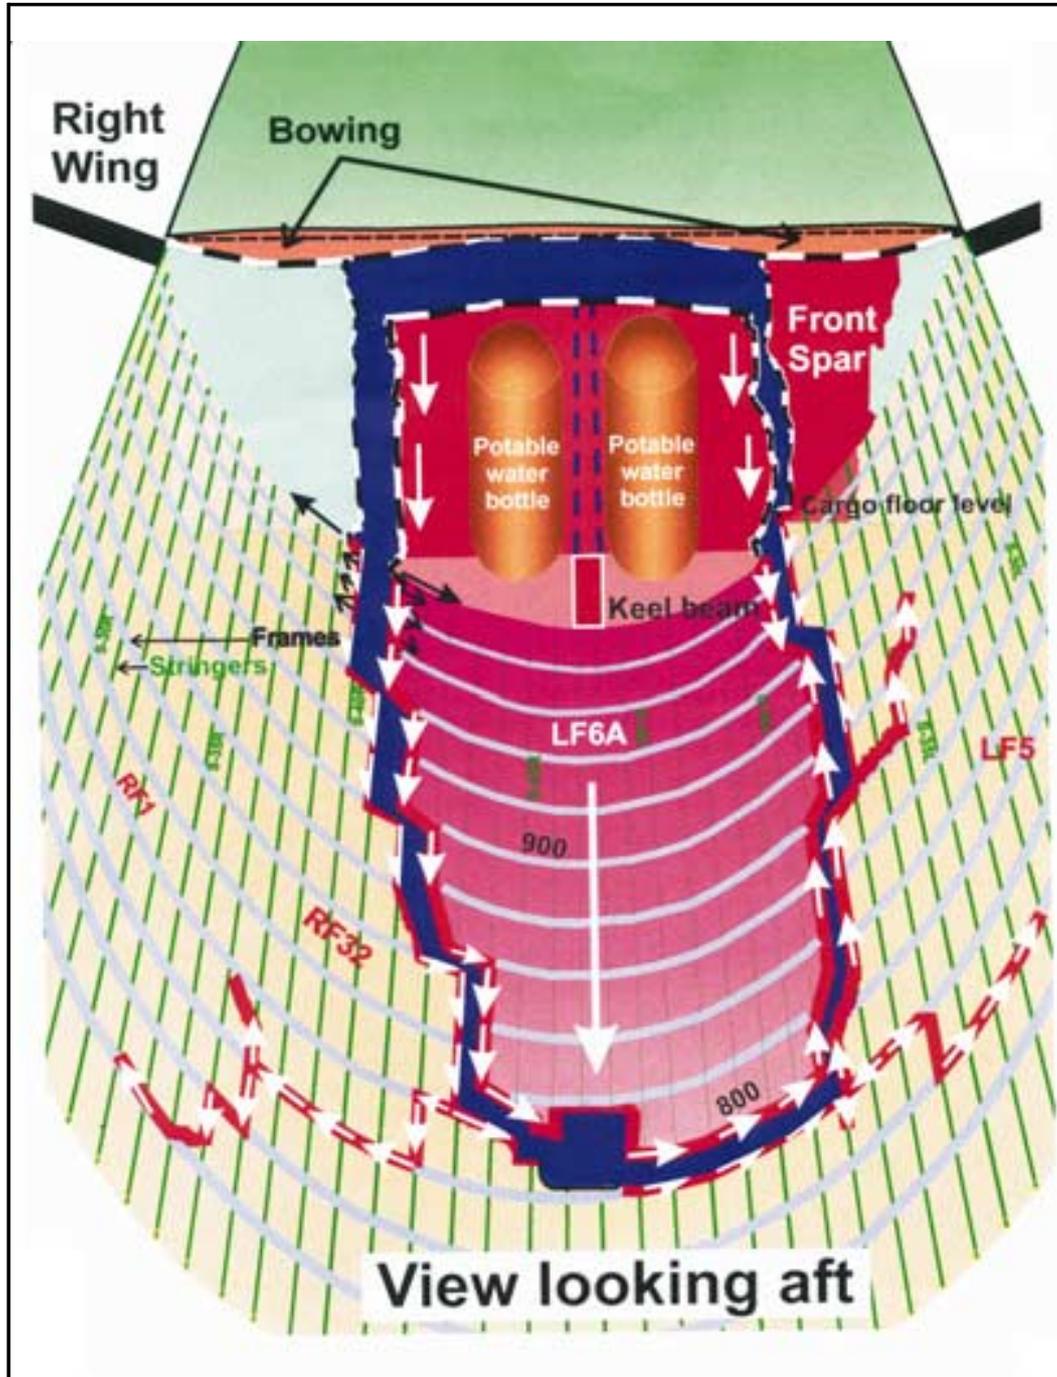
**Figure 30.** A schematic drawing of the lower portion of the fuselage skin in the area

The detailed examinations of the fuselage red zone pieces are an example of how these examinations were successful in determining an important segment of the breakup sequence. Figure 30 shows a schematic drawing of the lower portion of the fuselage skin in the area forward of the front spar. In this figure, the earlier fuselage skin fractures have been highlighted, and arrows have been added to indicate the direction of cracking in these earlier fractures. Of all of the fuselage fractures examined, only a limited number (all of which were on pieces recovered from the red zone) could be classified as earlier fractures (that is, consistent with in-plane loading). Further detailed examination of the rivet-to-rivet fracture pattern in these earlier fuselage fractures generated information on crack propagation directions and indicated that the earliest fracturing was of the lower fuselage, beginning at the front spar of the WCS. (The methodology used to determine the sequence of fracture in the fuselage red zone pieces was typical of the approach used for the entire airplane structure.)

On the basis of cracking directions of the fuselage skin, the Sequencing Group determined that the initial fuselage skin cracking (at stringer 40 right just forward of the front spar, about STA 1000) propagated forward and toward the bottom center of the airplane, then continued circumferentially in both directions and back toward the front spar on the lower left side. This fuselage cracking then quickly progressed<sup>202</sup> around three sides of a large piece of fuselage belly structure (subsequently identified primarily as piece LF6A). See figure 30 for a diagram of this cracking in the fuselage; piece LF6A is located in the center of this figure.

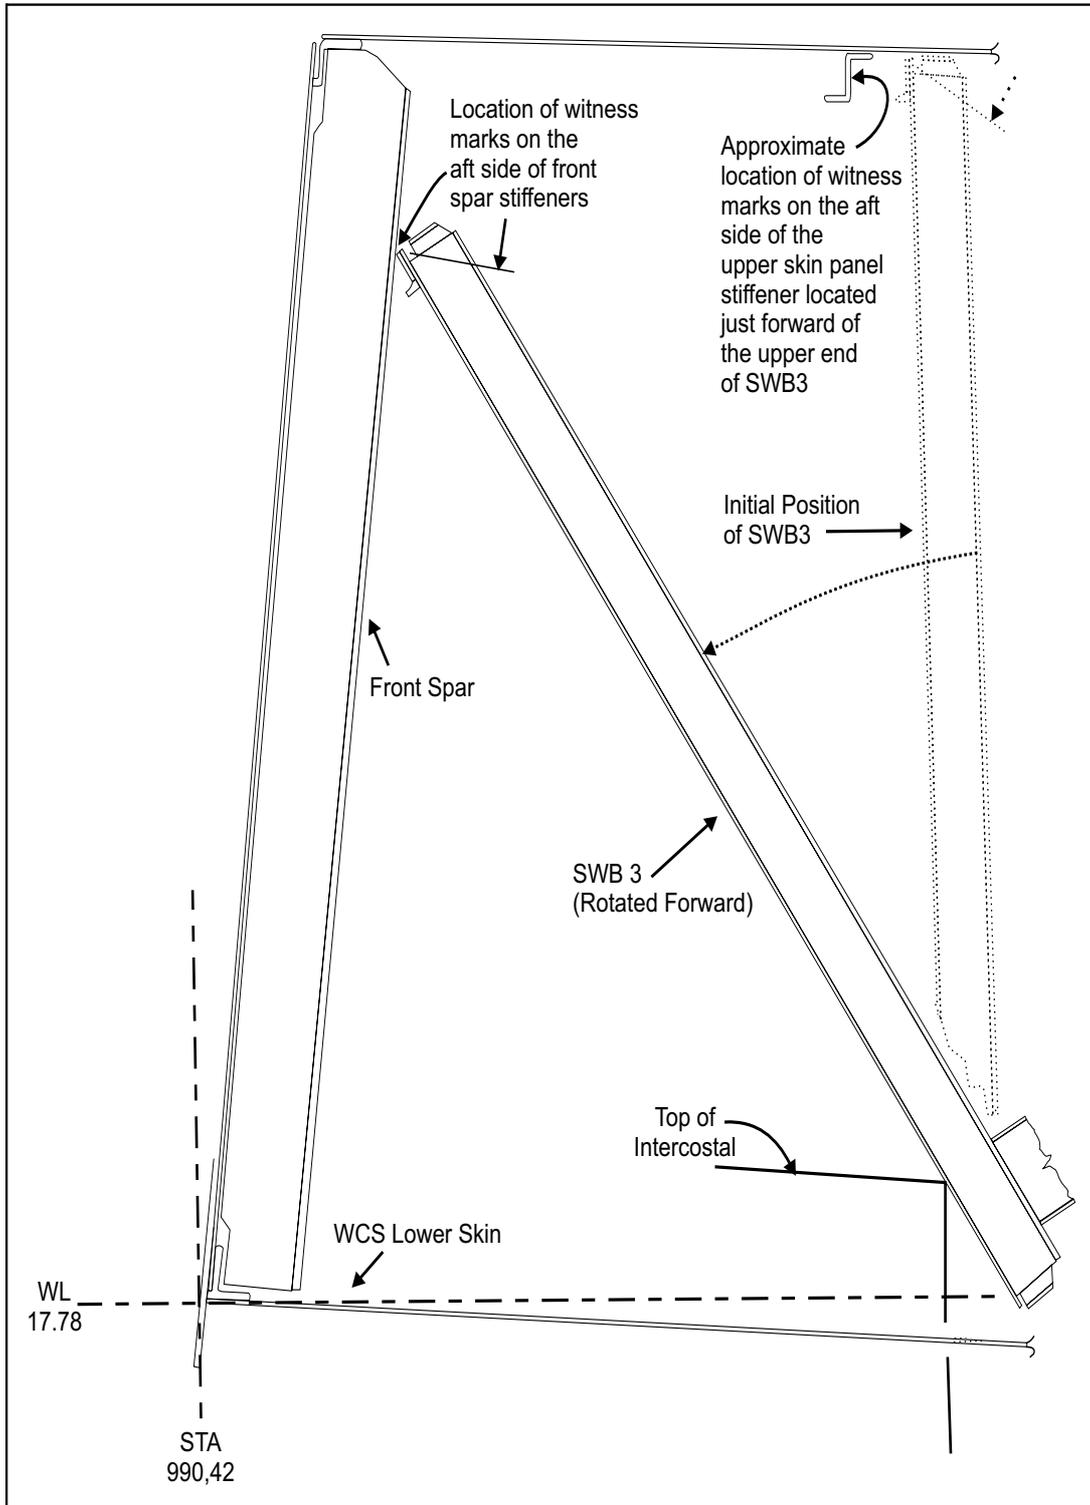
**Figure 31.** Diagram showing the approximate shape of the upper skin panel stiffener and its location before being struck by SWB3 as the beam rotated forward.

As the upper portion of SWB3 rotated forward, hinging on the still-attached lower chord, the upper chord impacted the aft side of the upper skin panel stiffener immediately forward of SWB3. (Figure 31 shows the approximate shape of this stiffener and its location before being struck by SWB3 as the beam rotated forward.) A geometrical layout of SWB3 and the upper and lower skin panels indicates that the forward rotation of SWB3 about its lower chord would result in an impact on the vertical flange of the stringer about 1.8 inches above the lower edge of the stringer (assuming no relative motion between the upper skin panel and SWB3). However, in the center of this stiffener, a witness mark was

noted at a distance of only 0.9 inch above the lower edge of the stringer. The difference between these values represents an upward vertical displacement of 0.9 inch between the upper and lower skin panels along the airplane's centerline when SWB3 impacted the stringer. The distance of the witness mark from the bottom of the stringer's vertical flange gradually increased at positions further outboard, indicating lesser amounts of upward vertical displacement outboard of the centerline. According to the sequencing study, the location of the marks left on the stiffener by SWB3 indicate that the upper skin of the CWT was likely bowed upward, apparently also as a result of an overpressure event within the CWT.

Continued forward and downward rotation of the top of SWB3 caused the upper end of SWB3 to impact the stiffeners on the aft surface of the front spar about 12 inches below the upper skin panel. This impact left a distinct set of marks on the front spar and initiated multiple failures near the top of that spar. (Figure 31 also shows the approximate orientation between the front spar and SWB3 as the aft side of the front spar was impacted by the upper end of SWB3.) Geometric evaluation and physical evidence indicated that the front spar was intact and in place when it was contacted by the upper end of SWB3. (The location of these SWB3 impact marks on the front spar was a major factor in the Sequencing Group's determination that fracture of the upper portion of SWB3 was the initial failure in the airplane structure.)

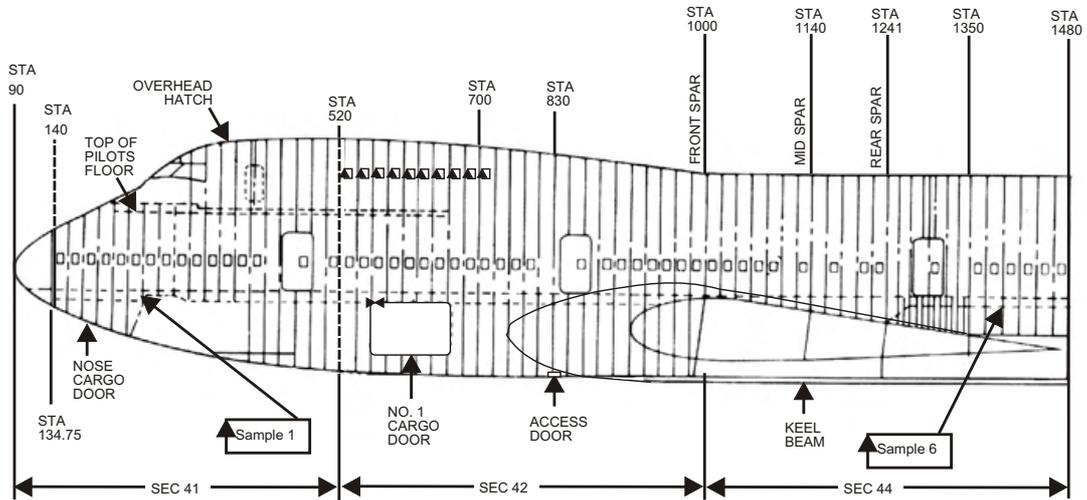
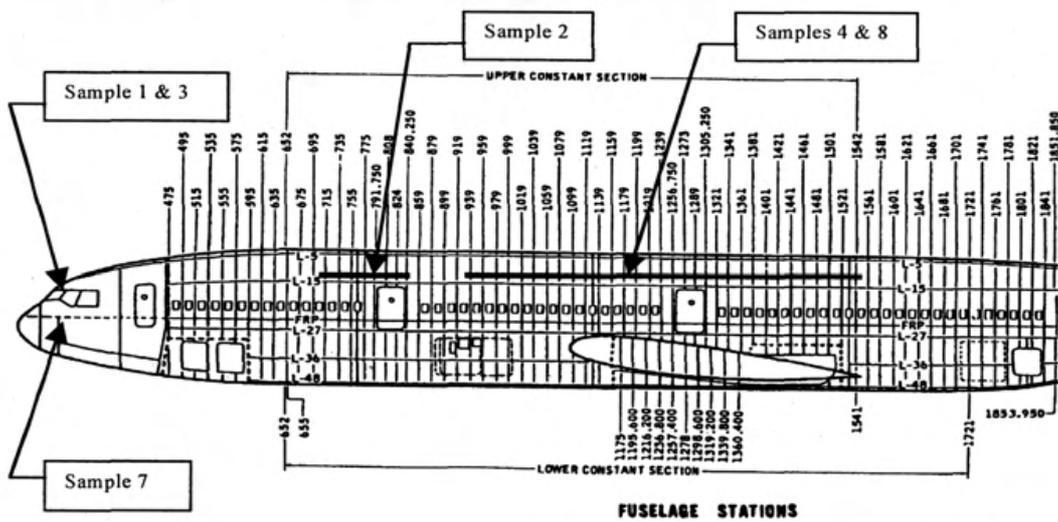
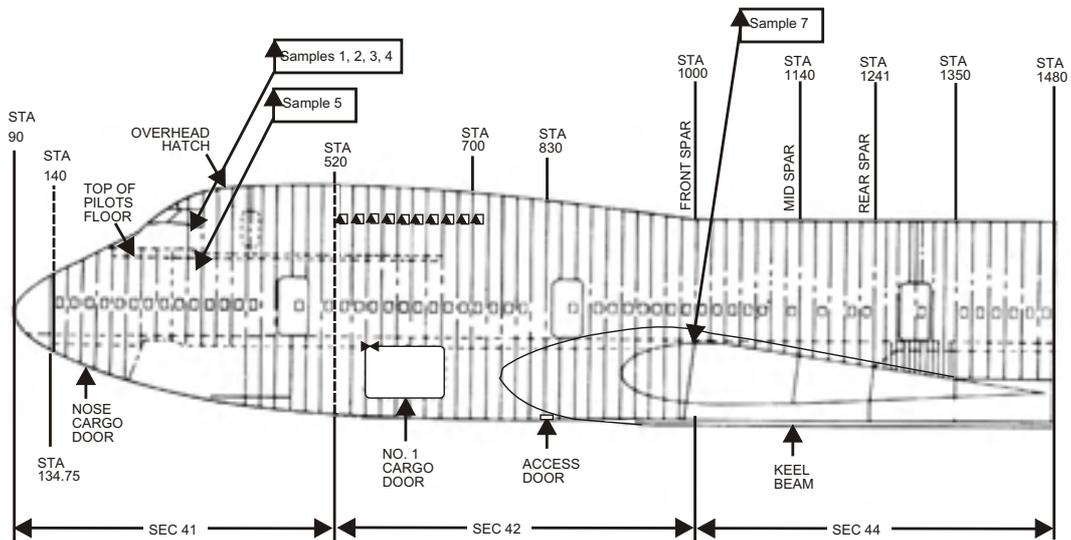
Figure 35a. Sample origination locations for the 747 manufactured in 1970.

Figure 35b. Sample origination locations for the DC-10 manufactured in 1973.

**Figure 35c.** Sample origination locations for the 747 manufactured in 1973.

4. The weak point in this wire type appears to be the lack of ability to maintain physical and electrical integrity during extended elevated thermal exposure with mechanical stress. As the wire ages, there is an increased risk of dielectric problems [breakdown of wire insulation integrity], mechanical damage and loss of electrical integrity.
5. No wire was submitted that was exposed to high levels of environmental exposure (such as wires from wheel wells, wing leading edges, etc.). Wire from these areas, would be expected to perform worse than the wire submitted. [See figures 35a, 35b, and 35c for sample locations.]

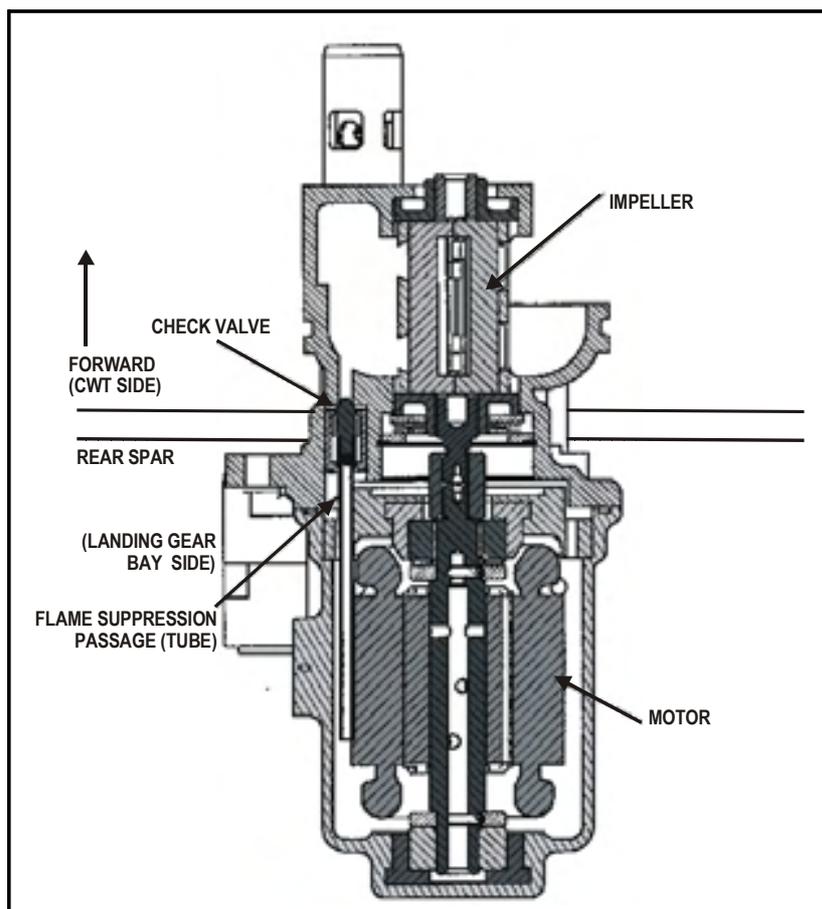
**Figure 37.** A diagram of a scavenge pump.

contained multiple explosions that were intentionally ignited within the pump motor cavity, preventing the ignition from transferring to the fuel tank. (Figure 37 is a diagram of a scavenge pump.) Because the Board became aware of instances in which the flame arrestor tube was broken or missing, investigators also conducted a series of tests to determine whether the scavenge pump motor housing would contain explosions with only one of the flame suppression system components (either the flame arrestor tube or the check valve) functioning. In all tests, the scavenge pump housing contained the explosions, and the explosive atmosphere surrounding the test pump did not ignite.

During its postaccident examination of other transport-category airplanes, the Safety Board observed that components in the electrical connector on a scavenge pump in a retired 747 were deteriorated. (Boeing ASBs 747-28A2194 and 747-28A0043, both dated January 18, 1996, “encouraged” operators to inspect for degradation in connectors.) Investigators observed that several scavenge pump electrical connectors had been manufactured of a material that degraded with long-term exposure to fuel. Boeing provided the Board with a service history for the 747 scavenge pump for the 10 years preceding the accident. When queried about the brevity of this history, Boeing indicated that most operators did not return the scavenge pumps to the manufacturer for overhaul.

As a result of these findings, Boeing issued ASB 747-28A2206, dated September 25, 1997, and AD 97-25-06, effective December 16, 1997. AD 97-25-06 contained the following summary:

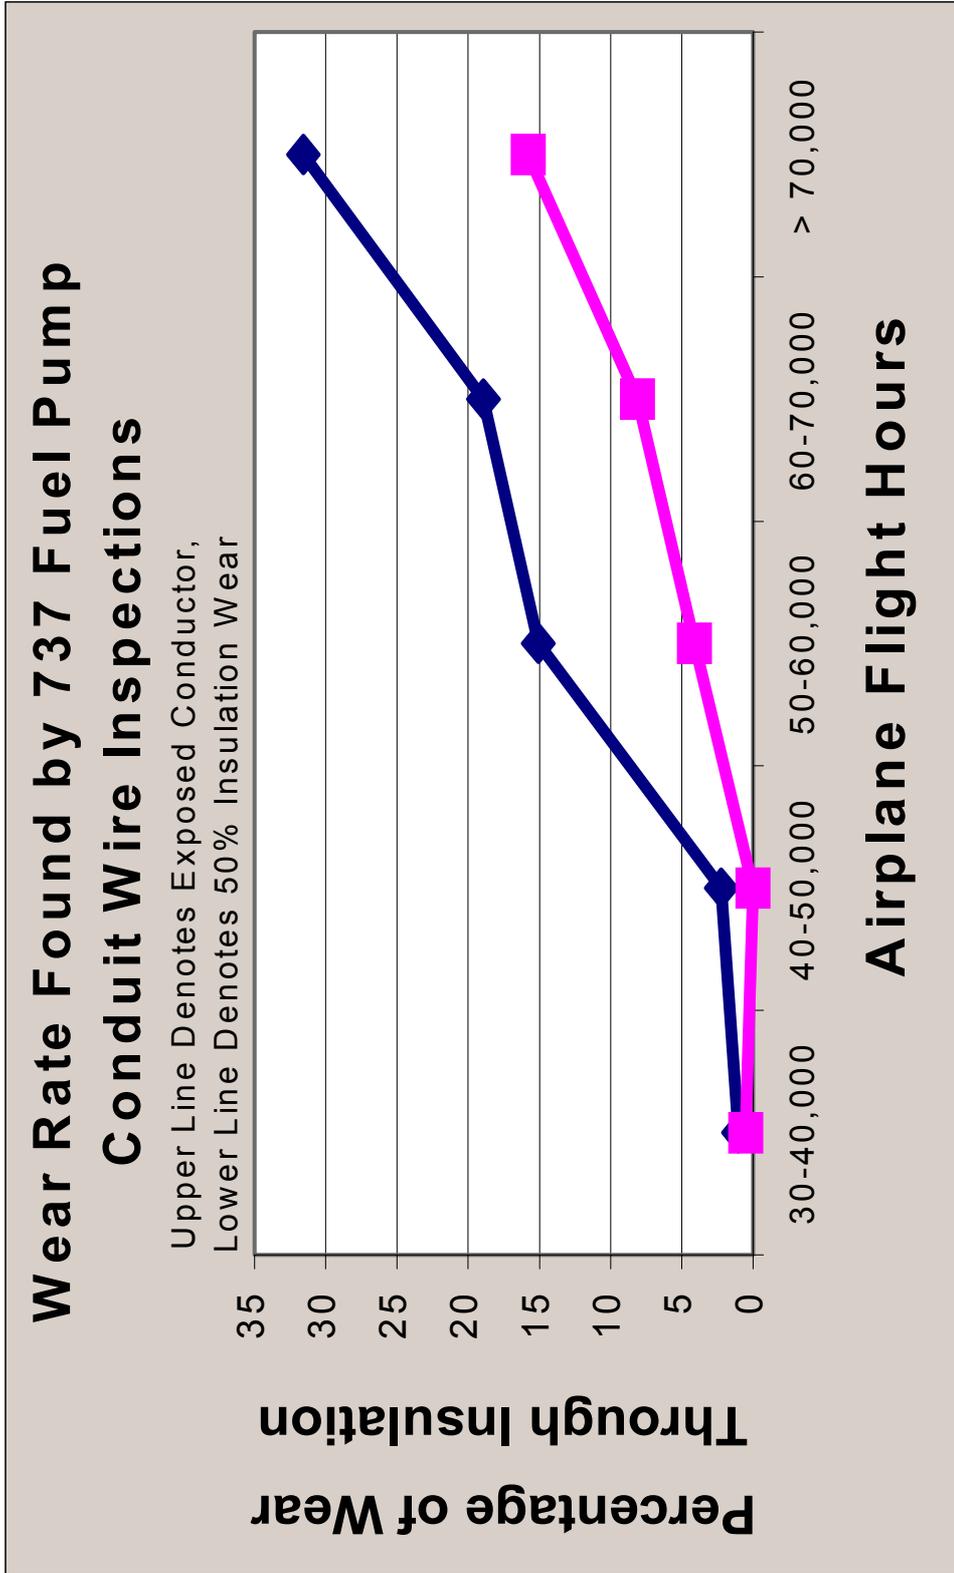
**Figure 39.** A chart showing the 737 fuel pump conduit wear rate that was identified by the FAA during representative 500 wire inspections.

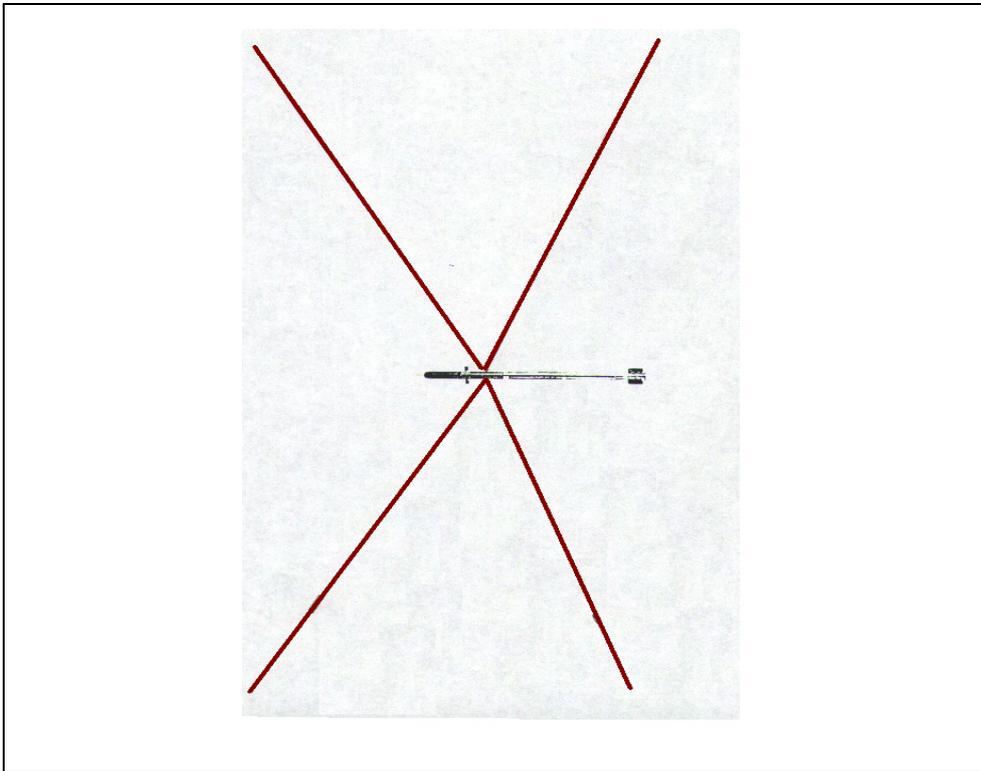
According to the MSIC, warhead detonation typically results in about 1,000 fragments of various sizes, with an average mass of less than 10 grains (0.0229 ounce), and a mass as large as 40 grains (0.0916 ounce) in the pattern shown in figure 43. MSIC reported that warhead fragments could have an initial velocity of up to 9,000 fps. Data obtained from the SURVIAC indicated that 10- and 40-grain fragments would require velocities of 3,500 fps and 2,000 fps, respectively, to penetrate the CWT if they impacted the bottom of the CWT at a right angle. Using the initial speed and speed decay rate for the warhead fragments, the Safety Board calculated that a detonation would have to occur 40 feet or less below the airplane's CWT for a fragment to retain sufficient velocity to penetrate the CWT.

**Figure 43.** Diagram of warhead detonation fragment pattern.

Simulations further showed that, because of the pattern in which missile fragments are dispersed after selfdestruction (see figure 43), launches from many of these positions would result in no fragments having a trajectory that would result in penetration of the CWT. For example, because of the nature of missile guidance, a launch from most positions on the perimeter shown in figure 44 would result in the missile catching the aircraft from behind. The area in front of the missile is not in the fragment dispersal area.

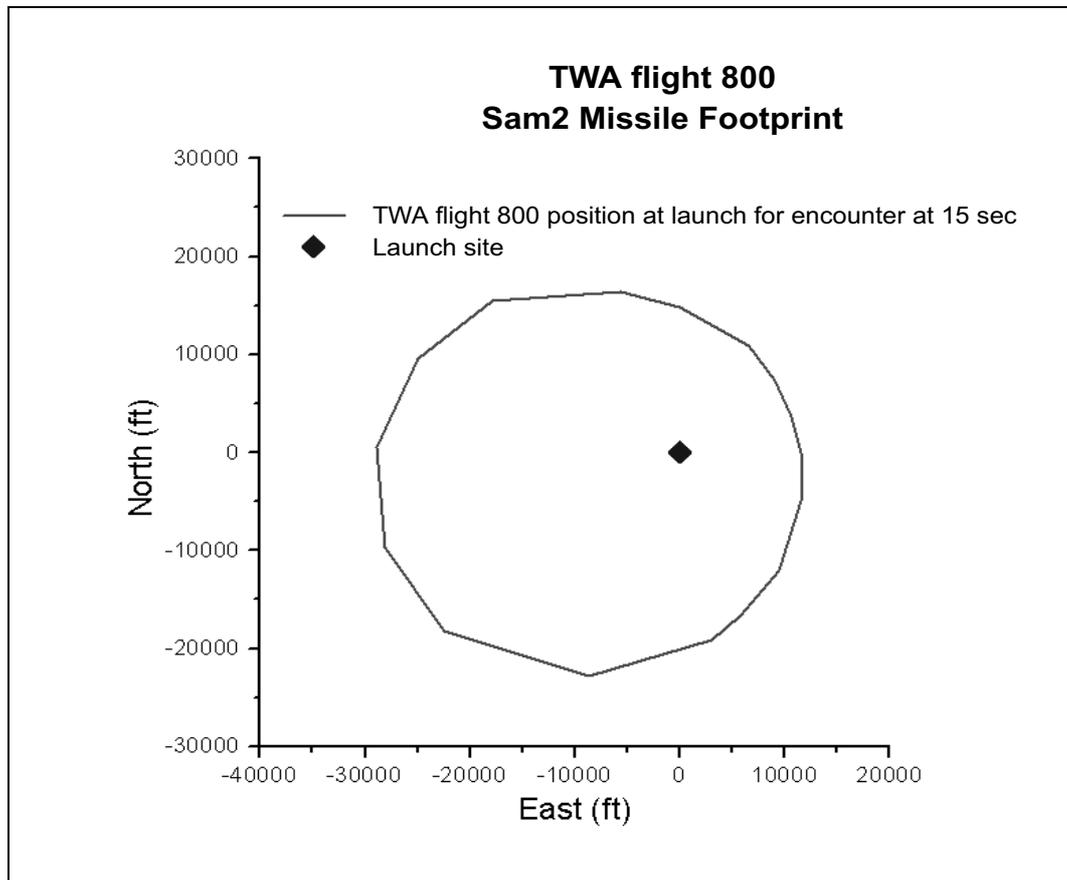
The Safety Board's computer simulations (using this missile performance data and taking into account the winds at the time of the accident) showed that the locations on the surface from which a missile launched at TWA flight 800 would result in selfdestruction within 40 feet of the airplane were extremely limited. Figure 44 shows airplane locations at which, if a high-performance missile were launched at the airplane, the missile would selfdestruct within 40 feet of the airplane. Note that, at the scale shown, the launch area that would result in a selfdestruction within 40 feet of the airplane is not as wide as the line showing the 15-second perimeter in this figure.

**Figure 44.** Diagram showing airplane and missile launch site locations that could result in missile selfdestruct within 40 feet of the plane.

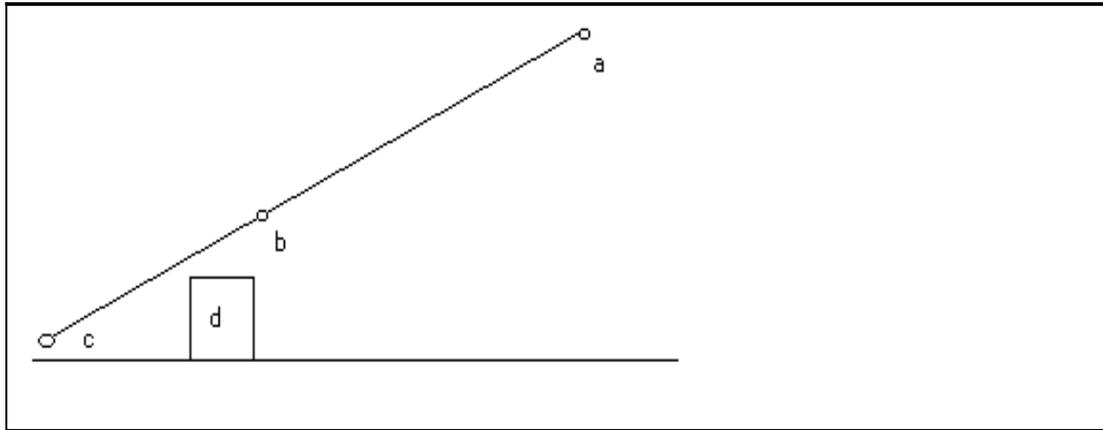
It should also be noted that witnesses observing the accident from Long Island would have been viewing it against a featureless background and, therefore, would have had few, if any, depth perception cues. Consequently, because of the tendency to perceive more distant objects as being about the same distance away as intervening objects (the equidistance tendency), the streak of light could have appeared closer to them than it actually was. The equidistance tendency is illustrated in figure 45, which depicts a person at point “c” observing an object at point “a” that appears at point “b” at the same perceptual distance as an intervening building at point “d.”

**Figure 45.** A graphical illustration of the equidistance tendency.

in the sky than it actually was, which explains why the streak of light may have been reported by some witnesses as having originated at the surface of the earth. It should be noted that almost all of the witnesses who reported that the streak of light originated at the surface viewed the streak of light on the far side of intervening terrain features, such as houses or the barrier island. These witnesses would have perceived the streak of light to be about the same distance as the intervening object because the elevation angle of the object would have been perceptually reduced.

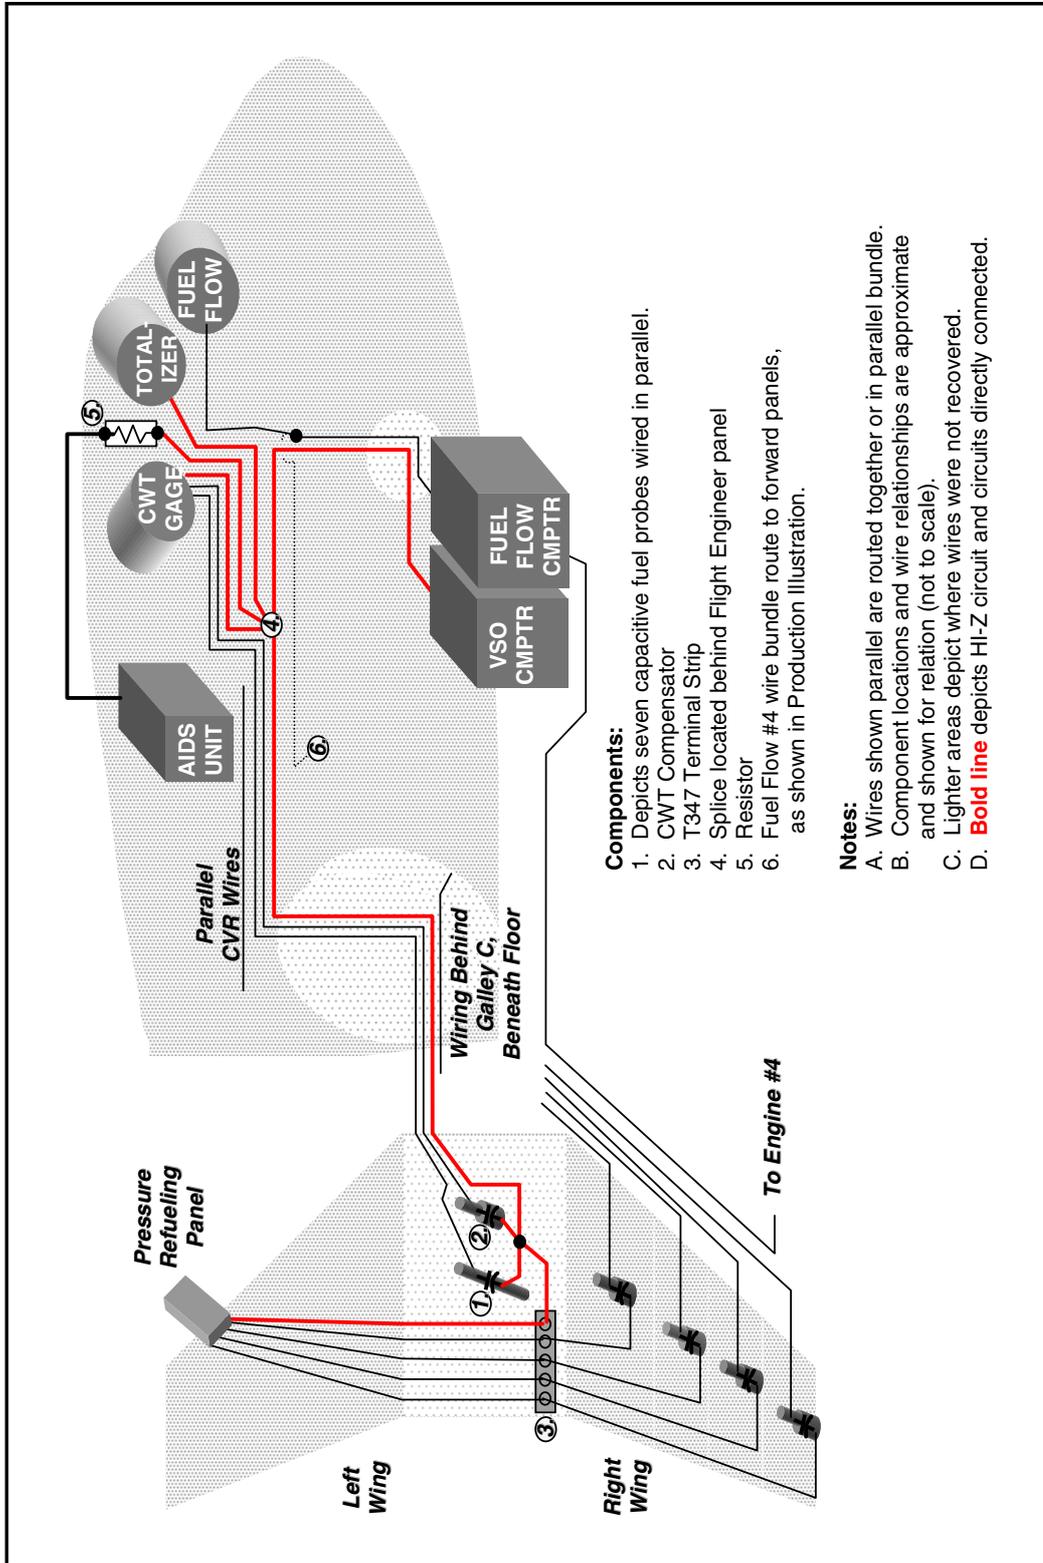
The CWT FQIS wiring in the 747 terminates at common connectors with the fuel quantity indicator, the totalizer gauge, the airborne integrated data system (AIDS), the volumetric shutoff (VSO), and the left wing refueling station; each of these connectors also includes terminating wires from circuits that carry 115 volts.<sup>605</sup> (See figure 46.) Short circuits in connectors have caused incidents in the past. For example, an October 22, 1995, incident involving roll/yaw oscillations on a 737 near Manchester, England, was attributed to a short circuit in the rudder circuitry of the incident airplane that resulted from lavatory fluid bridging the pins within an electrical conductor.

Figure 46. Diagram of the center wing tank fuel quantity indication system wiring on the 747 and its common connectors.
